Manhole Inspection Summary

Manhole # S51QQ_003MH

Inspection ☐ Is Incomplete Rating: **3) Fair**

Insp Date: **3/17/08 10:00 AM**

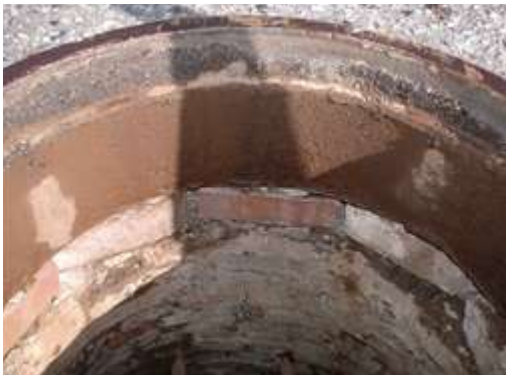
Defect 1

Chimney / Frame Adjustment ☒ Exists Material: **Brick** ☐ Parged Height: **9** (in.)

Condition: ☐ Sound ☐ Cracked ☐ Root Intrusion ☒ **Loose Brick** ☐ Deteriorated

Infiltration: ☐ None ☐ Joint ☐ Cracks ☒ **Mortar** ☐ Roots ☒ **Wall**

Adjustment Joint

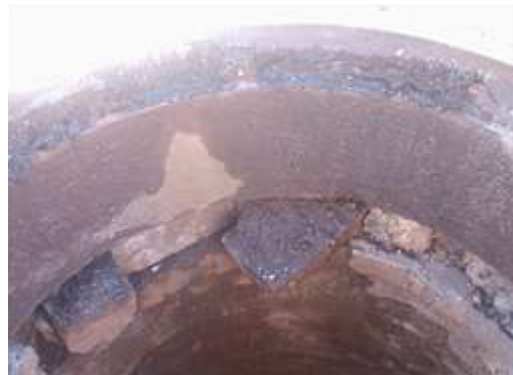
Defect 2

Frame Offset: **2** (in.) Condition: ☐ Sound ☐ Cracked ☒ **Leaks**

Frame Leaks

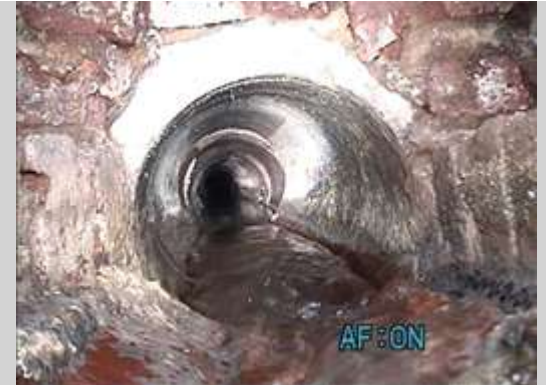
12 O'Clock Outflow

8 in. Circular Gravity Sewer
Pipe Out @ 12 O'Clock

Pipe Height: **8.4** (in.) Rod and Bar (Angled)
Pipe Material: **Clay** ☐ Pipe Lined
Invert Depth: **8.10** (ft.) Flow Characteristics: **Fast**
Deposits: ☒ None ☐ Mud ☐ ~~Gravy~~ ☐ Debris ☐ Grease
Silt Depth: (in.) Deposits Extent:
Infiltration: **None** Pipe Seal Cond: **Sound**

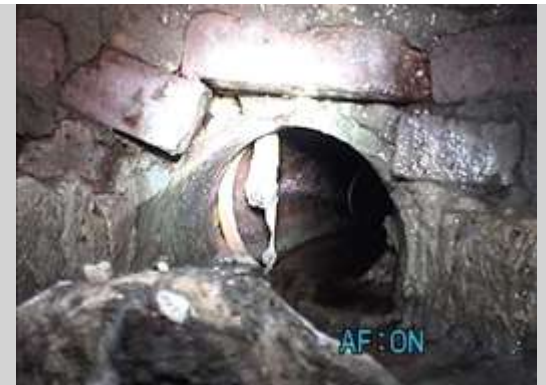
9 O'Clock Inflow

8 in. Circular Gravity Sewer
Pipe In @ 9 O'Clock

Pipe Height: **8.4** (in.) Rod and Bar (Angled)
Pipe Material: **Clay** ☐ Pipe Lined
Invert Depth: **7.70** (ft.) Flow Characteristics: **Fast**
Deposits: ☐ None ☐ Mud ☒ ~~Gravy~~ ☒ Debris ☐ Grease
Silt Depth: **1** (in.) Deposits Extent: **Light**
Infiltration: **None** Pipe Seal Cond: **Unknown**
